RE: ASARCO East Helena Smelter, Transmittal of EPA Inspection
Report for Corrective Action Assessment Inspection, September 8, 2006

**U.S. EPA REGION VIII
TECHNICAL ENFORCEMENT PROGRAM
RCRA COMPLIANCE INSPECTION REPORT**

Facility: ASARCO East Helena Plant
100 Smelter Road
East Helena, MT

Inspection Type: Corrective Action Assessment Inspection

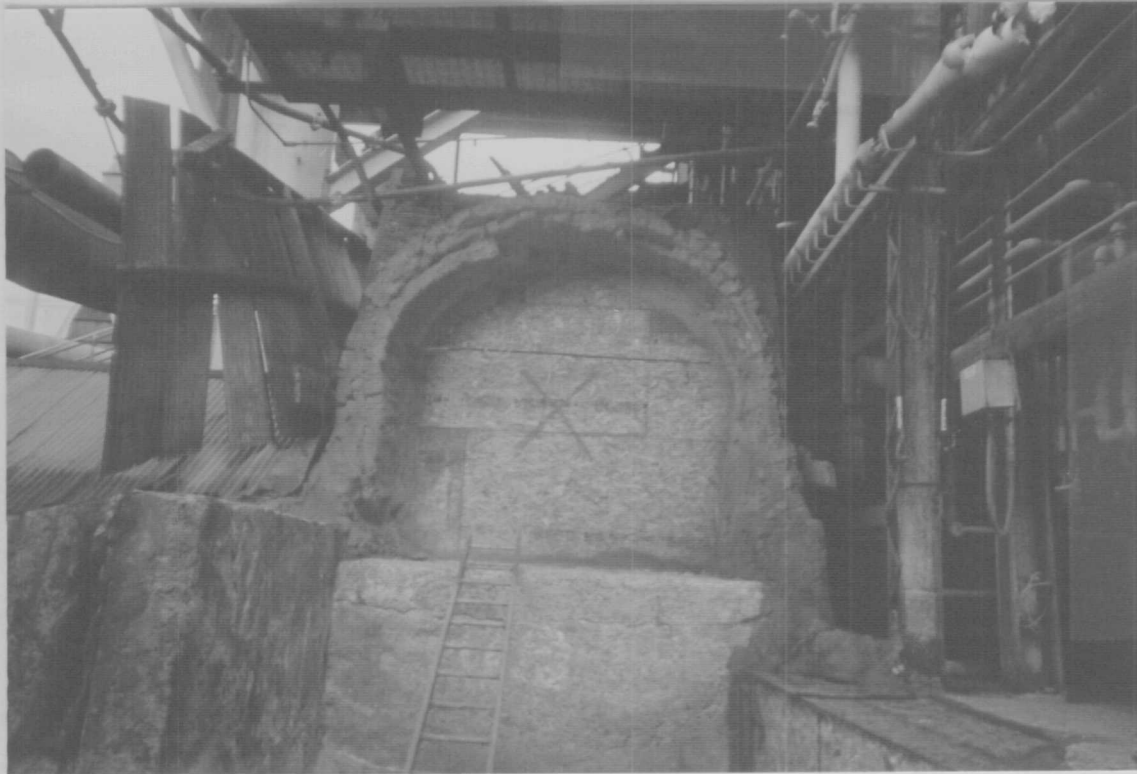
Roll 1, Photo 7; Facility: ASARCO East Helena Smelter; Subject: Blast Furnace Flue Behind No. 1 Furnace, Stop Demo for 2006; Photographer: Linda Jacobson; Date: August 31, 2006

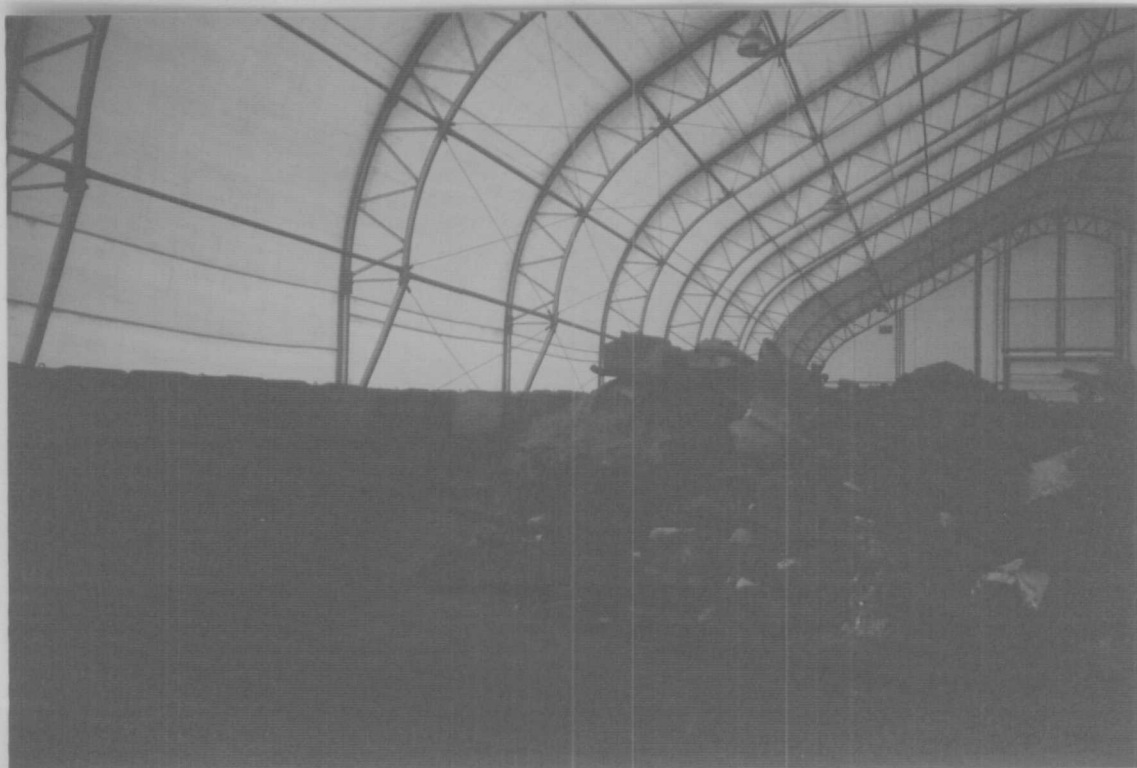
Roll 1, Photo 20; Facility: ASARCO East Helena Smelter; Subject: Waste Storage Inside Bailey Building (Note: waste height is too high); Photographer: Linda Jacobson; Date: August 31, 2006

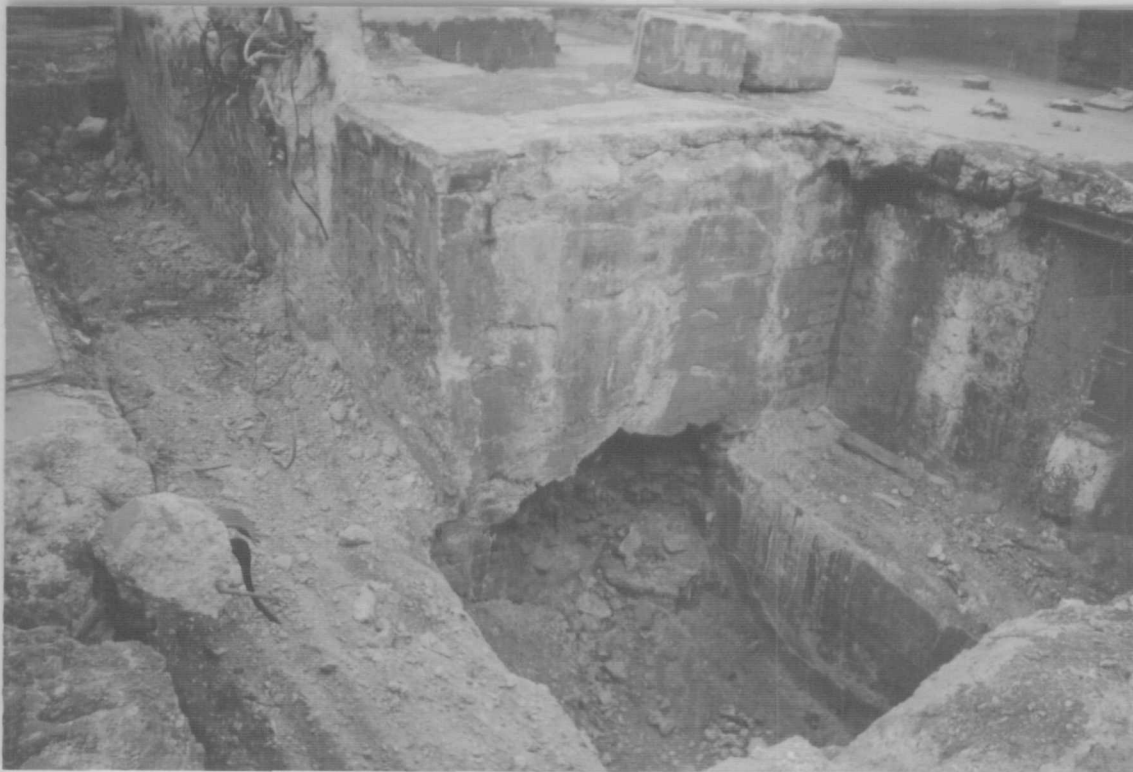
Roll 1, Photo 27; Facility: ASARCO East Helena Smelter; Subject: Depressed Areas at Sinter Plant; Photographer: Linda Jacobson; Date: August 31, 2006

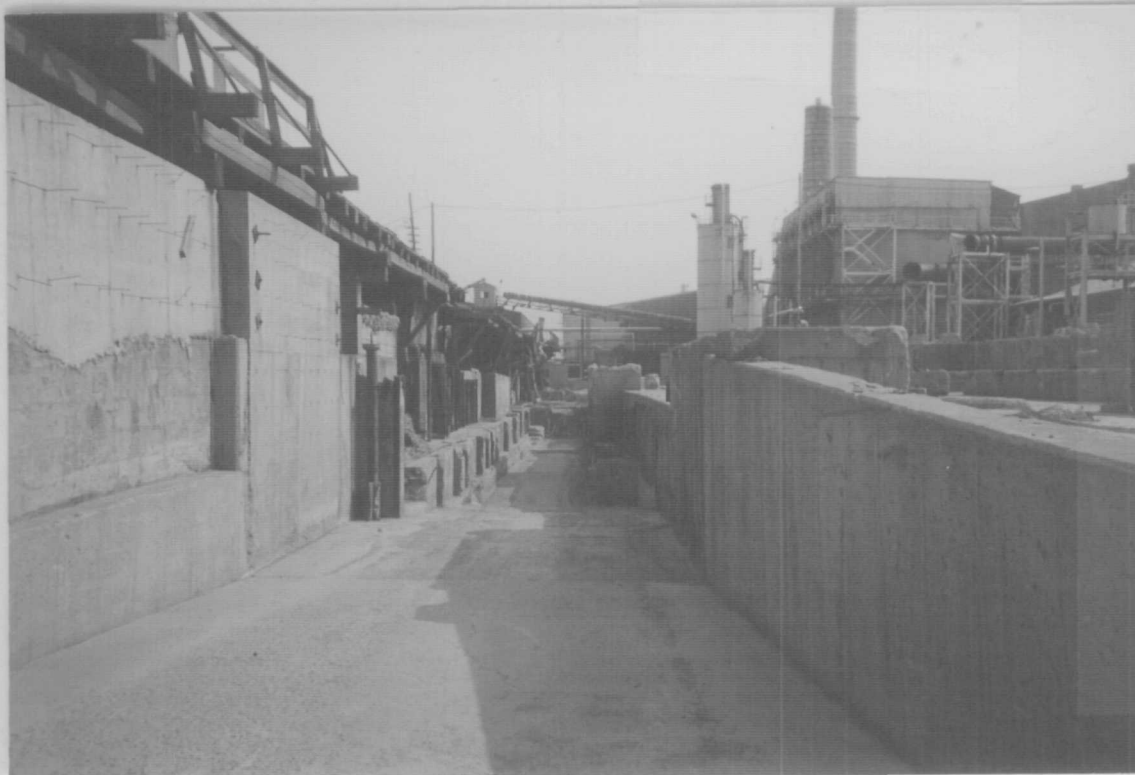
A walkthrough was conducted of a portion of the plant to allow photographic documentation of some of the building demolition activities. Photos were taken at the Sinter Plant including the Larry Pit, exposed soils, foundations, and the drain sump. Mr. Nickel indicated that the exposed soils will be sampled for the full suite of metals and covered with a temporary cap. The sump drain, the elevator, and other low lying spots will be filled in with slag.

Roll 2, Photo 1; Facility: ASARCO East Helena Smelter; Subject: Larry Pit at Former Sinter Plant; Photographer: Linda Jacobson; Date: September 8, 2006

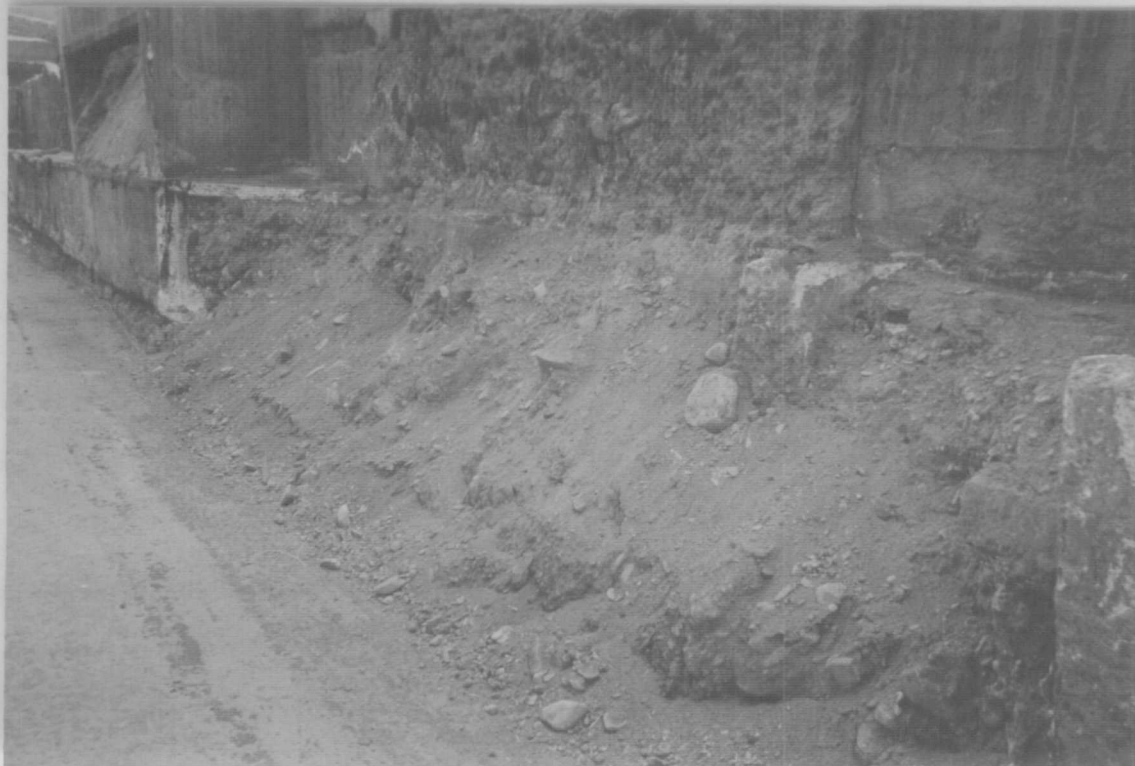
Roll 2, Photo 2; Facility: ASARCO East Helena Smelter; Subject: Exposed Soils at Former Sinter Plant; Photographer: Linda Jacobson; Date: September 8, 2006

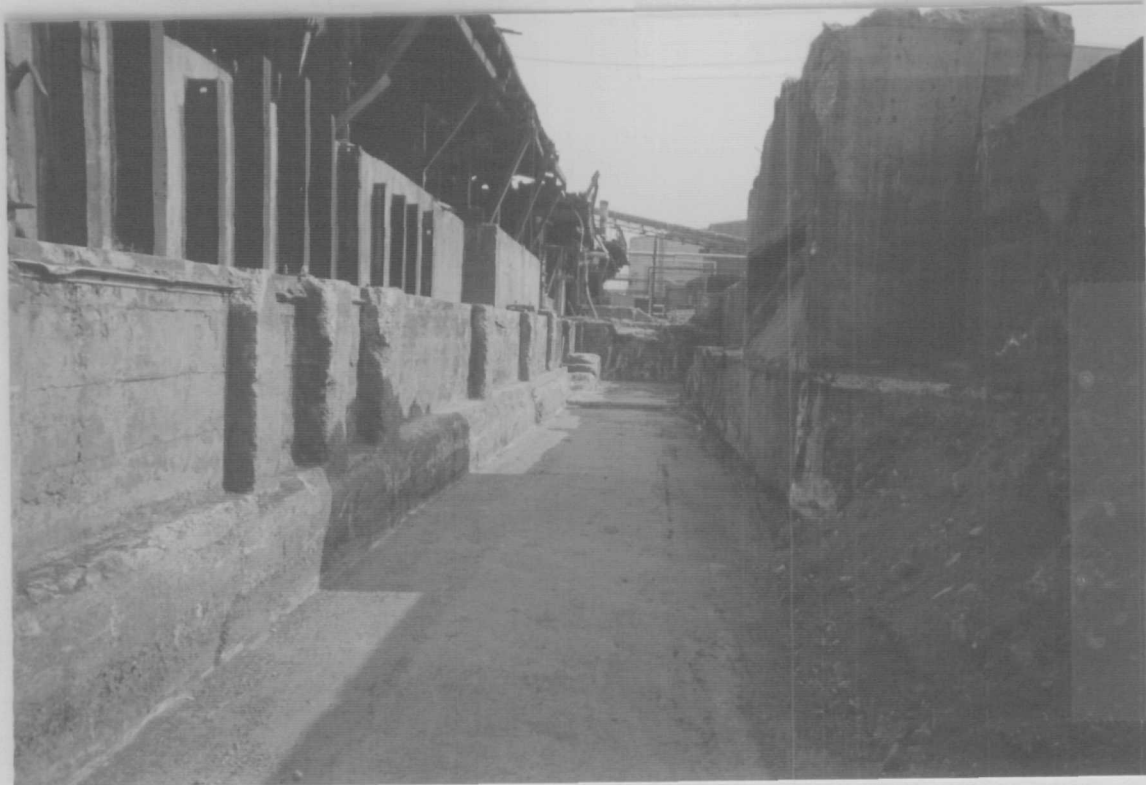
Roll 2, Photo 3; Facility: ASARCO East Helena Smelter; Subject: Larry Pit at Former Sinter Plant; Photographer: Linda Jacobson; Date: September 8, 2006

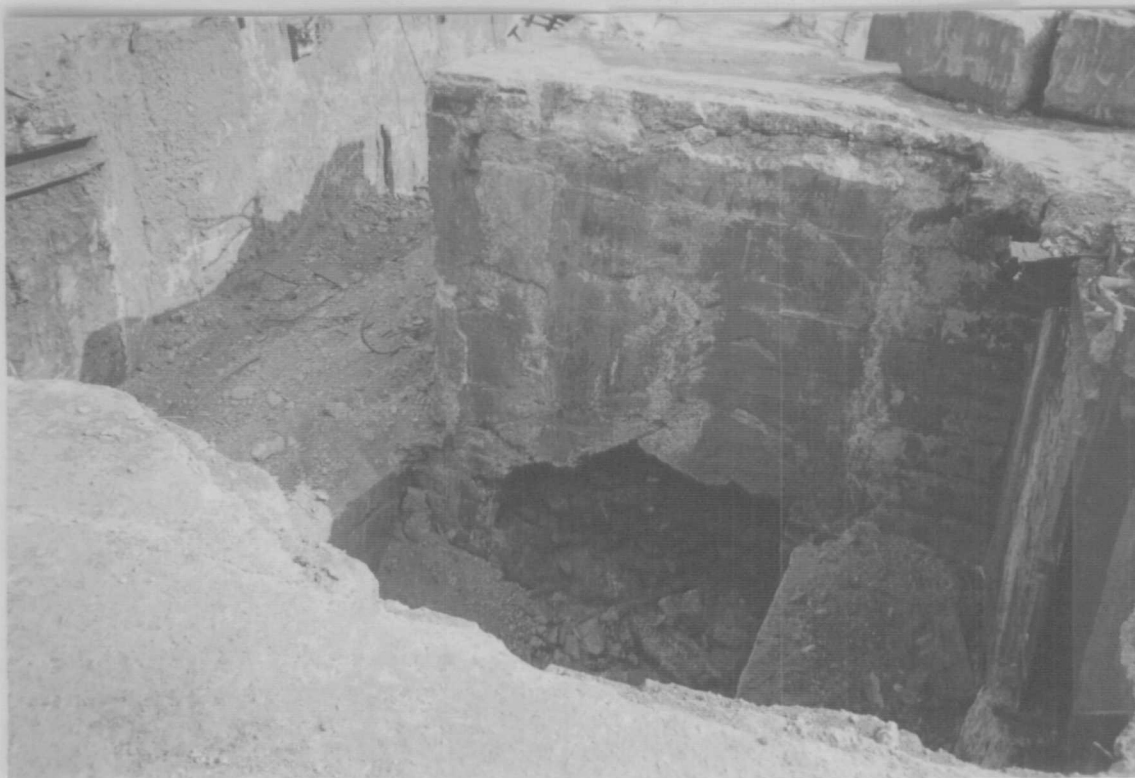
Roll 2, Photo 5; Facility: ASARCO East Helena Smelter; Subject: Depressed Area at Sinter Plant; Photographer: Linda Jacobson; Date: September 8, 2006

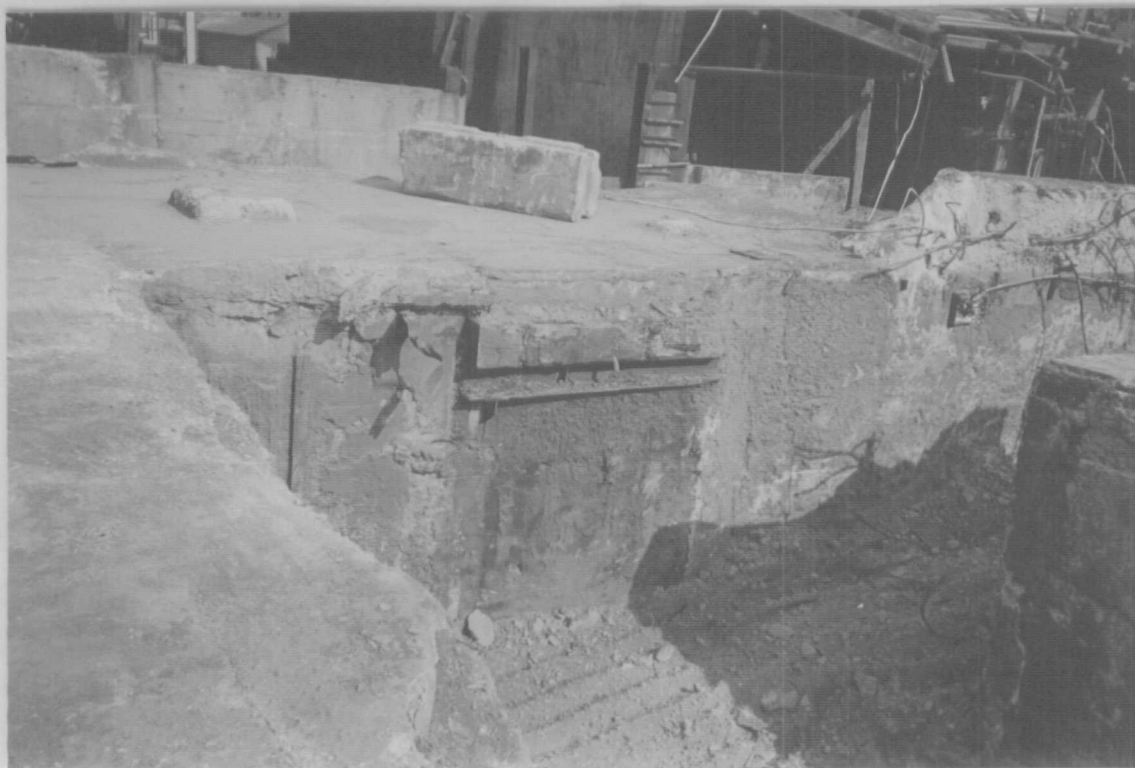
Roll 2, Photo 6; Facility: ASARCO East Helena Smelter; Subject: Depressed Area at Sinter Plant; Photographer: Linda Jacobson; Date: September 8, 2006

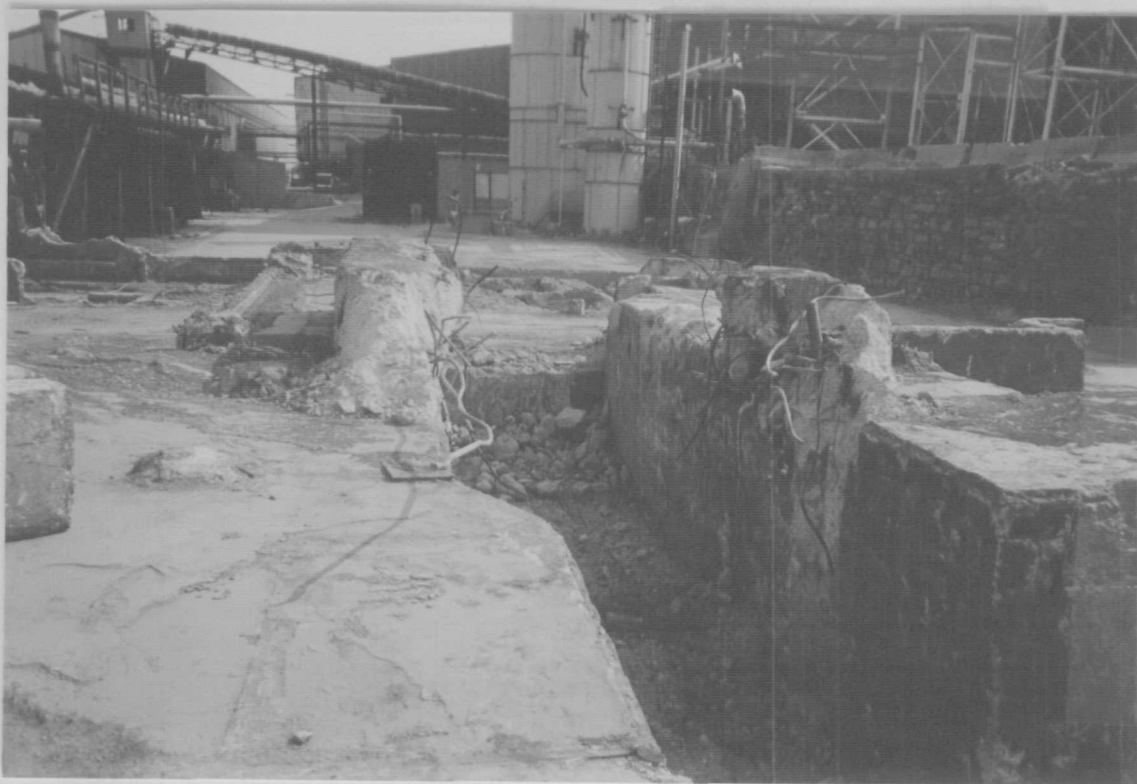
Roll 2, Photo 7; Facility: ASARCO East Helena Smelter; Subject: Exposed Areas of Soil at Sinter Plant; Photographer: Linda Jacobson; Date: September 8, 2006

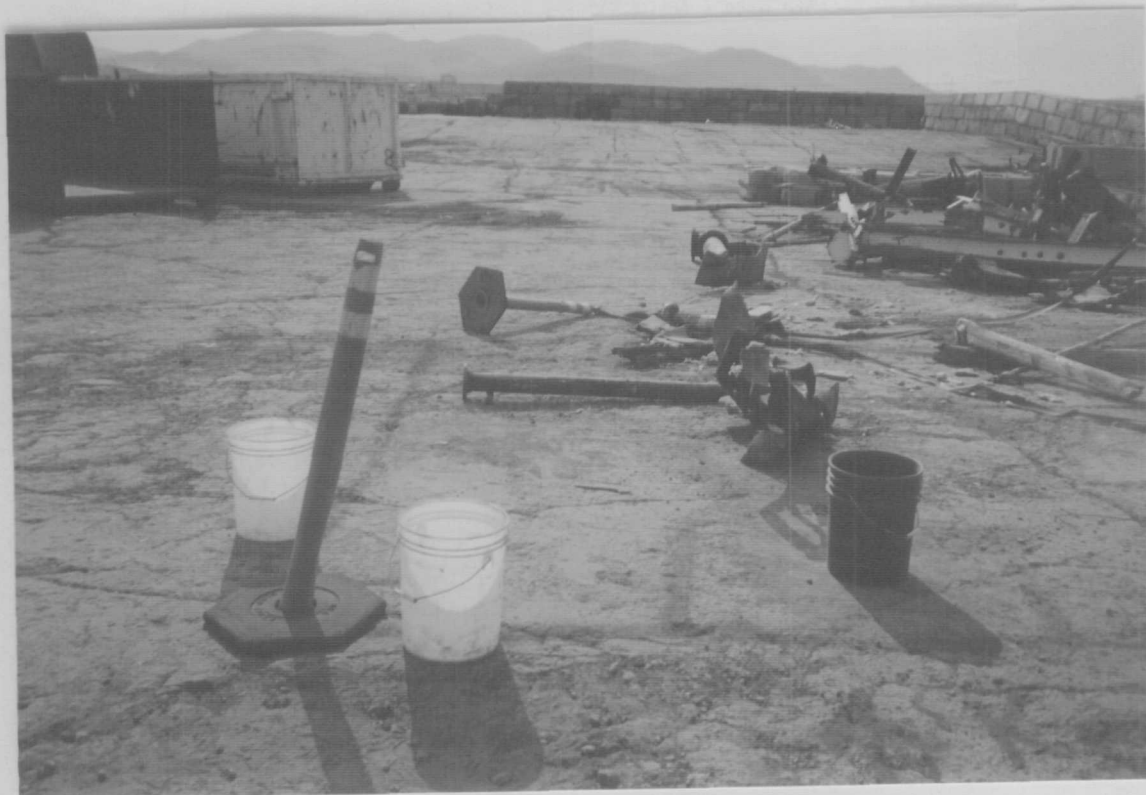
Ms. Jacobson was also shown the damaged PCB-containing capacitor. The capacitor had been in use at the Acid Plant. After being damaged, it was placed in the lay down area; this area had now been painted as a red boxed area for PCB grid sampling. The capacitor had now been moved to a safer location near the blast furnace bag house; it was wrapped in plastic and red danger tape.

Roll 2, Photo 11; Facility: ASARCO East Helena Smelter; Subject: Portion of Lay Down Area
Needing PCB Grid Sampling, Red-Boxed; Photographer: Linda Jacobson;
Date: September 8, 2006

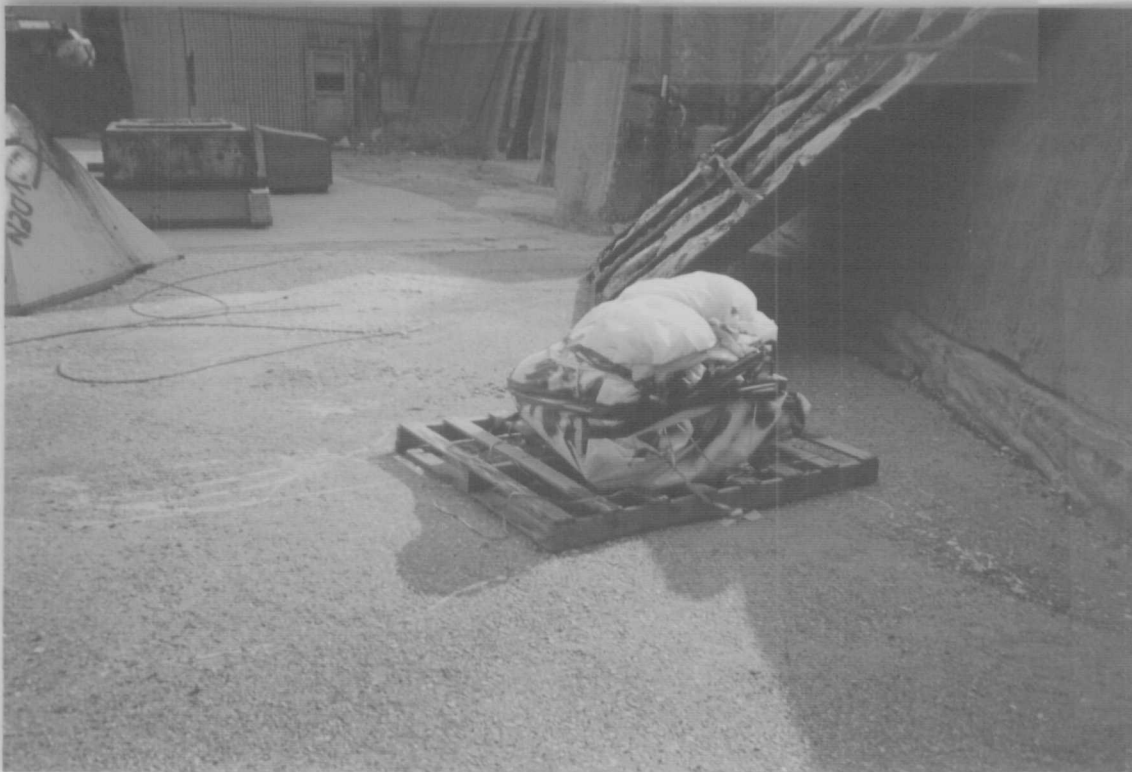
On September 7, 2006, Mr. Nickel had informed Ms. Jacobson via telephone that Envirocon, the demolition consultant had damaged a 1.1 gallon PCB-containing capacitor. Mr. Nickel had reported this to Francis Tran, EPA PCB permit writer in Denver, who told him to have Envirocon follow-up.

Roll 2, Photo 13; Facility: ASARCO East Helena Smelter; Subject: Damaged Capacitor;
Photographer: Linda Jacobson; Subject: September 8, 2006

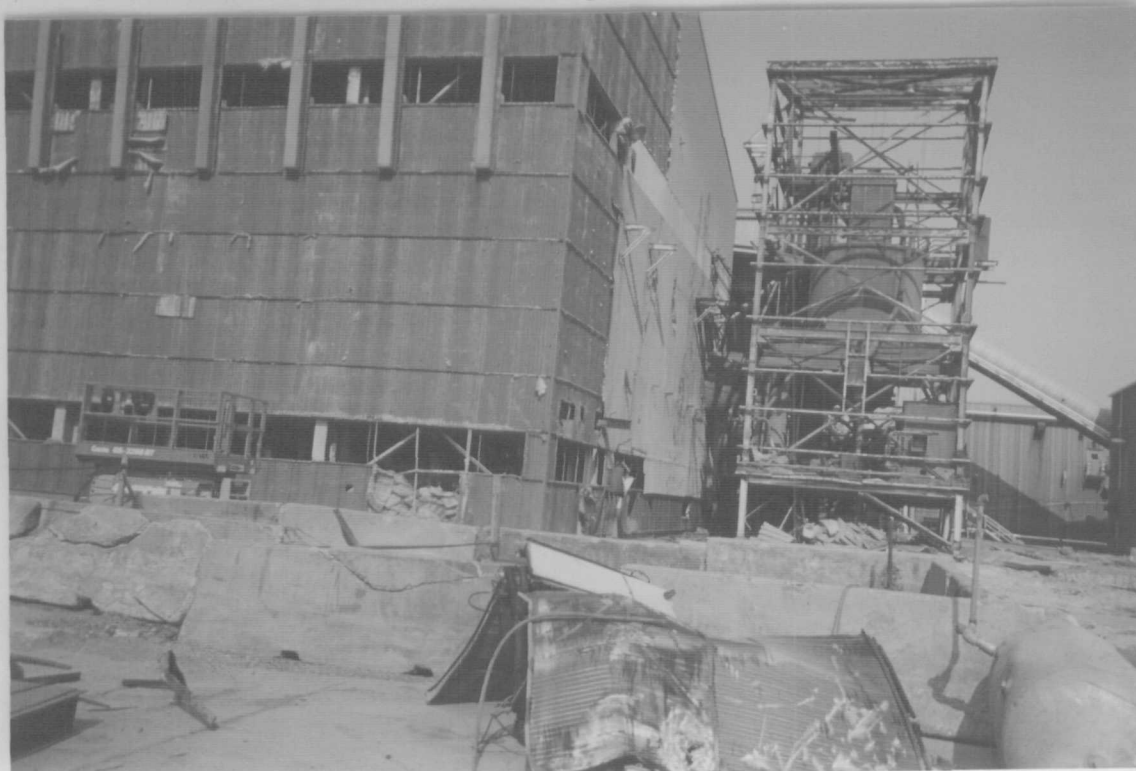
Ms. Jacobson photographed the exterior of the Hot Cottrell Building from which the galbestos insulation was being removed pursuant to state asbestos regulations. Mr. Nickel drove them to the location of the proposed Phase 2 CAMU cell. Ms. Jacobson also photographed this area.

Roll 2, Photo 14; Facility: ASARCO East Helena Smelter; Subject: Hot Cottrell Building;
Photographer: Linda Jacobson; Date: September 8, 2006

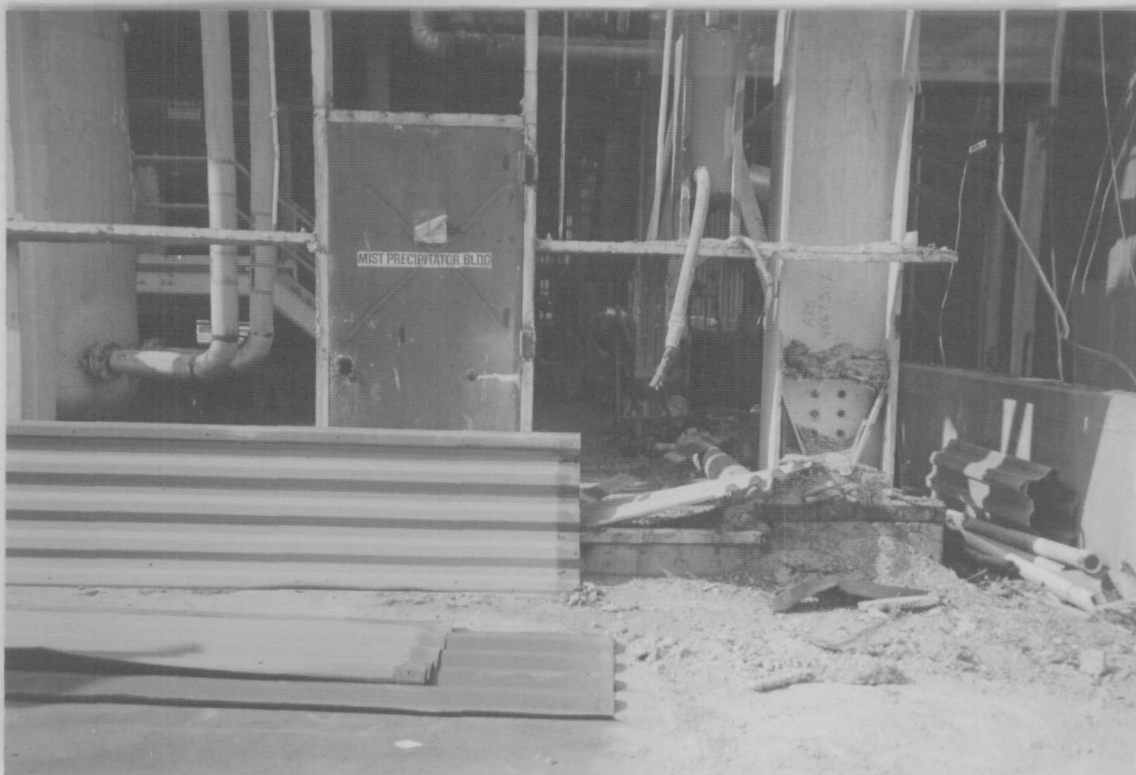
Roll 2, Photo 15; Facility: ASARCO East Helena Smelter; Subject: Location of Capacitor Prior to Demolition; Photographer: Linda Jacobson; Date: September 8, 2006

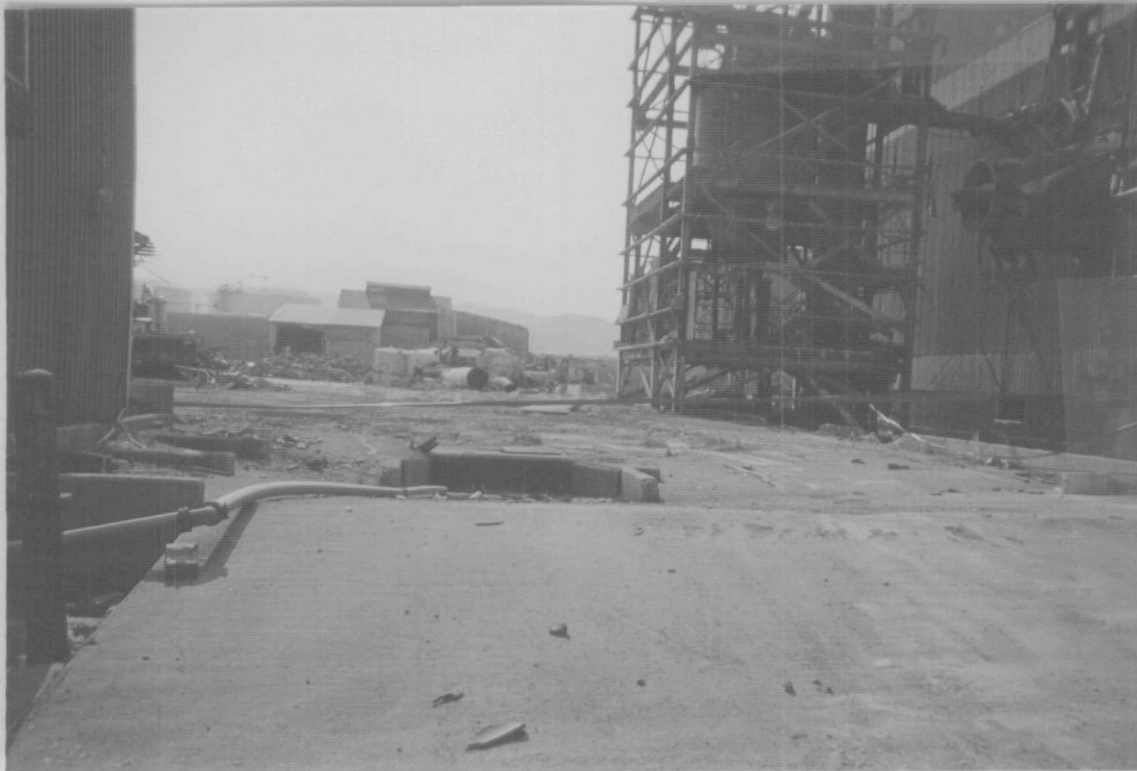
Roll 2, Photo 17; Facility: ASARCO East Helena Smelter; Subject: Exposed Soils Between Hot Cottrell and Mist Precip. Building; Photographer: Linda Jacobson
Date: September 8, 2006
